## INVESTIGATING TORNADO SCARS IN TEXAS

William Monfredo

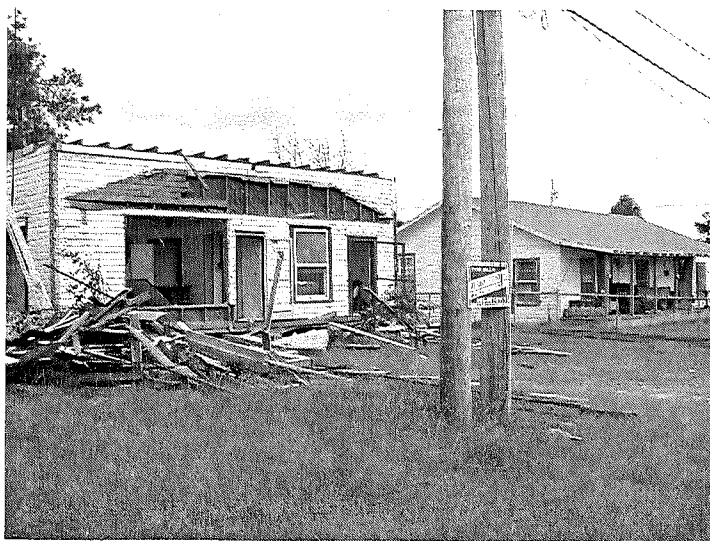
**Figure 5.** The structure on the left, in De Kalb, damaged by a 1999 F-3 tornado, stands in contrast to the repaired home next to it; note the newer lighter-colored replacement telephone pole next to the darker (unused) pole.

The existence of the tornado scars and scar elements generally appears scattered, random, and chaotic. The De Kalb study site two and one-half years after the 1999 F-3 tornado remains an exception. The central portion of the De Kalb study site is still missing commercial buildings and appears highly impacted with a concentrated string of empty foundations extending for several blocks. Foundations of homes and old driveways are particularly common tornado-scar elements at all study sites, reinforcing the notion that the proper engineering and strength of structures is paramount for buildings and people to survive violent tornadoes.
